## **APPENDIXES**

This Appendix contains prints of digital images depicting natural and cultural aspects of the project area on Kelleys Island, Ohio. The Appendix is subdivided into 4 sections which comprise the following topics:

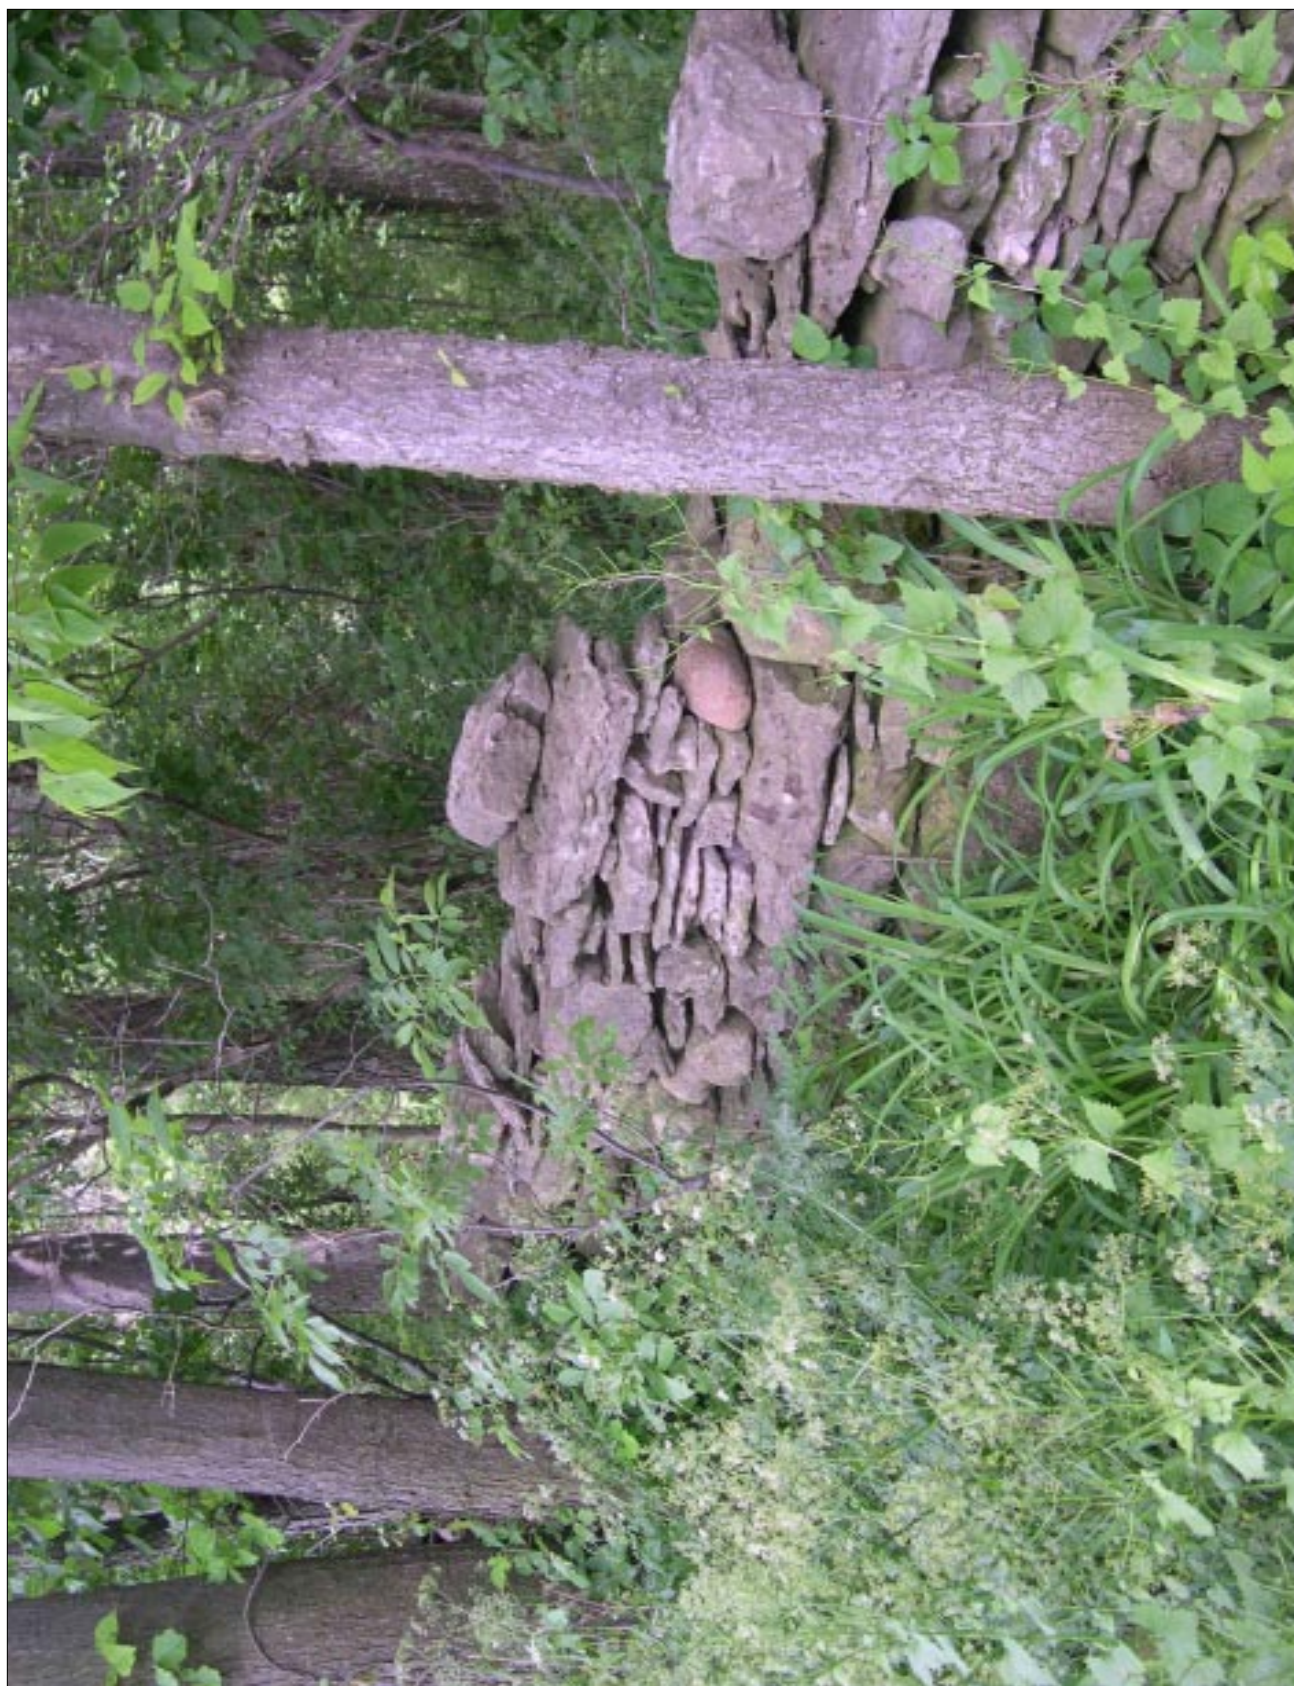
*Image LW-2. Lincoln Stone Wall midway along its reach on the Predevelopment. Ltd. tract; note large slabs used in the top course of limestone (May 27, 2004).*

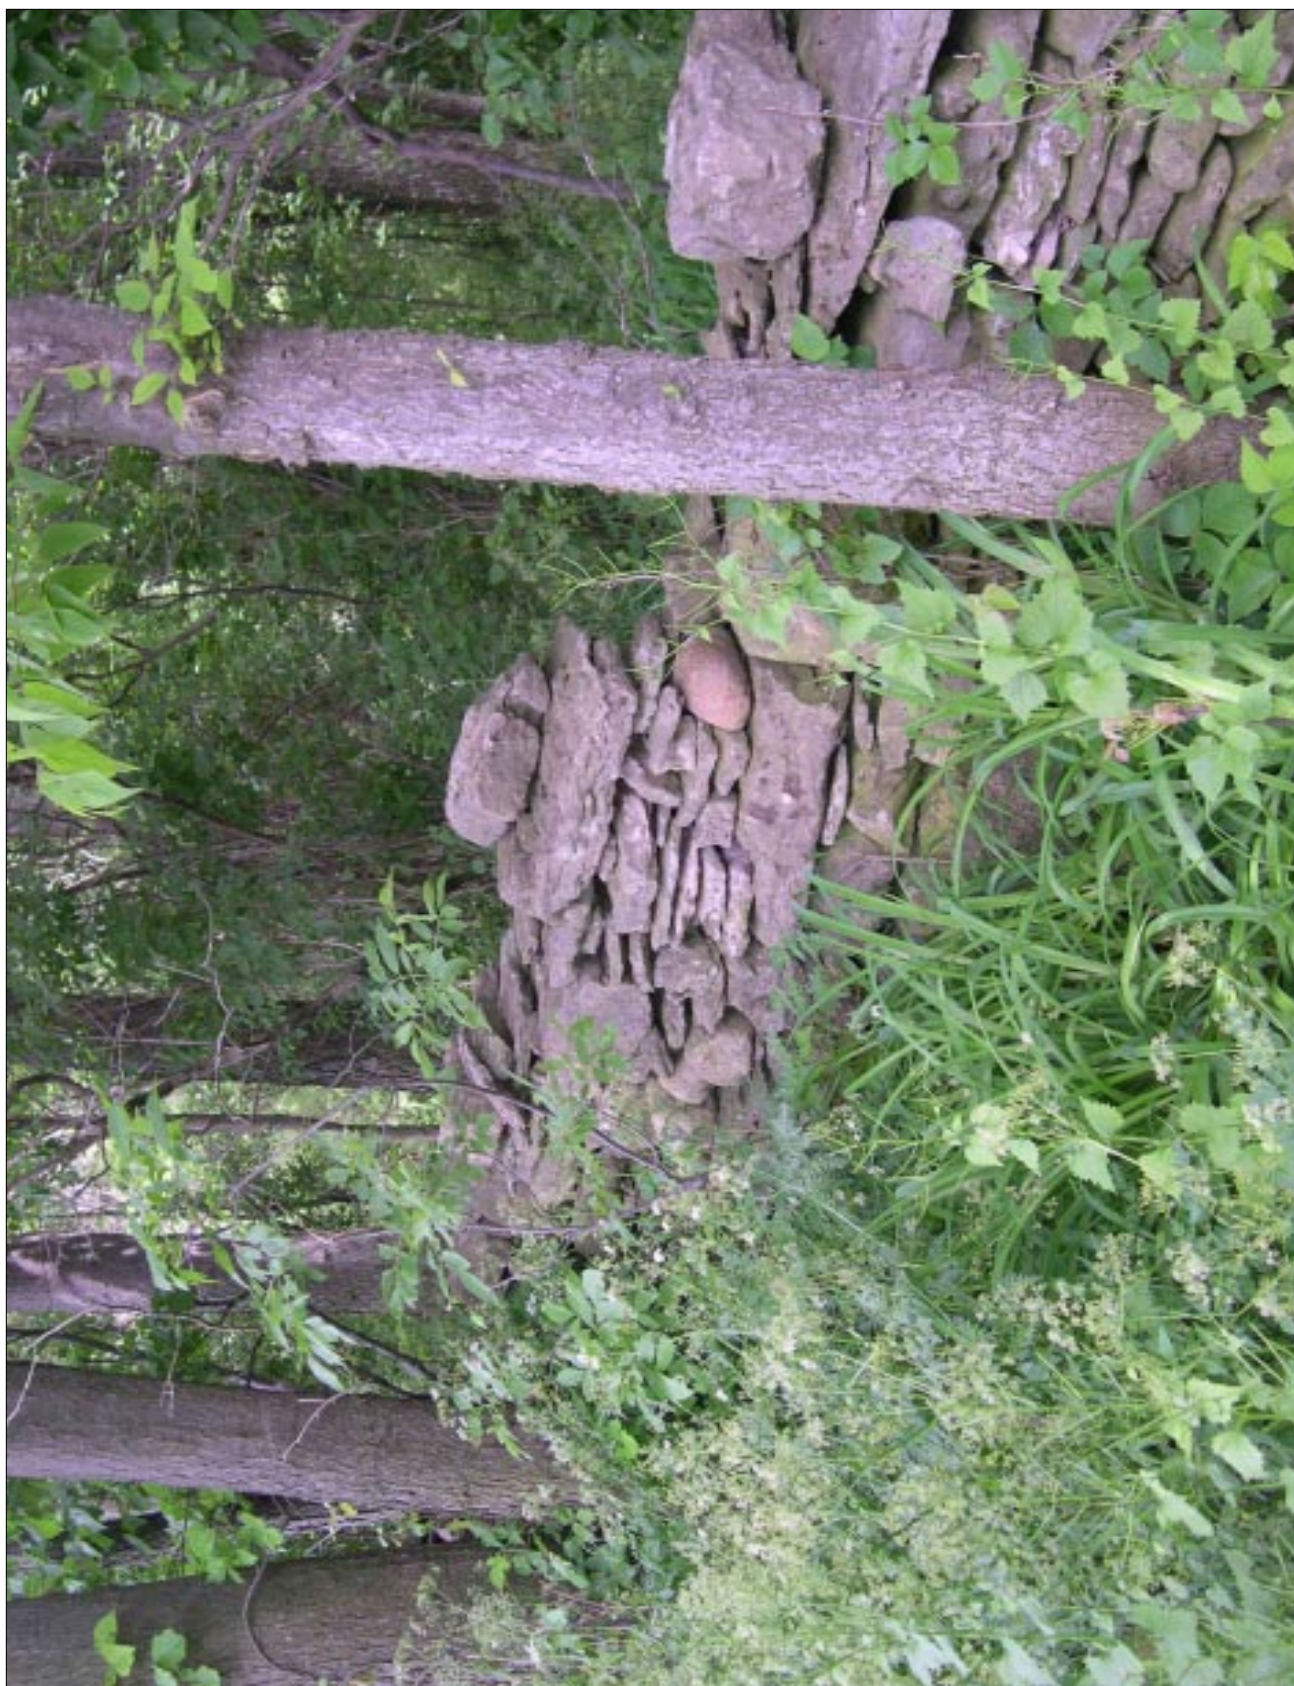
*Image LW-3. Lincoln Stone Wall in the vicinity of the Lincoln House foundation; note glacial boulders intermixed with the limestone slabs (May 27, 2004).*

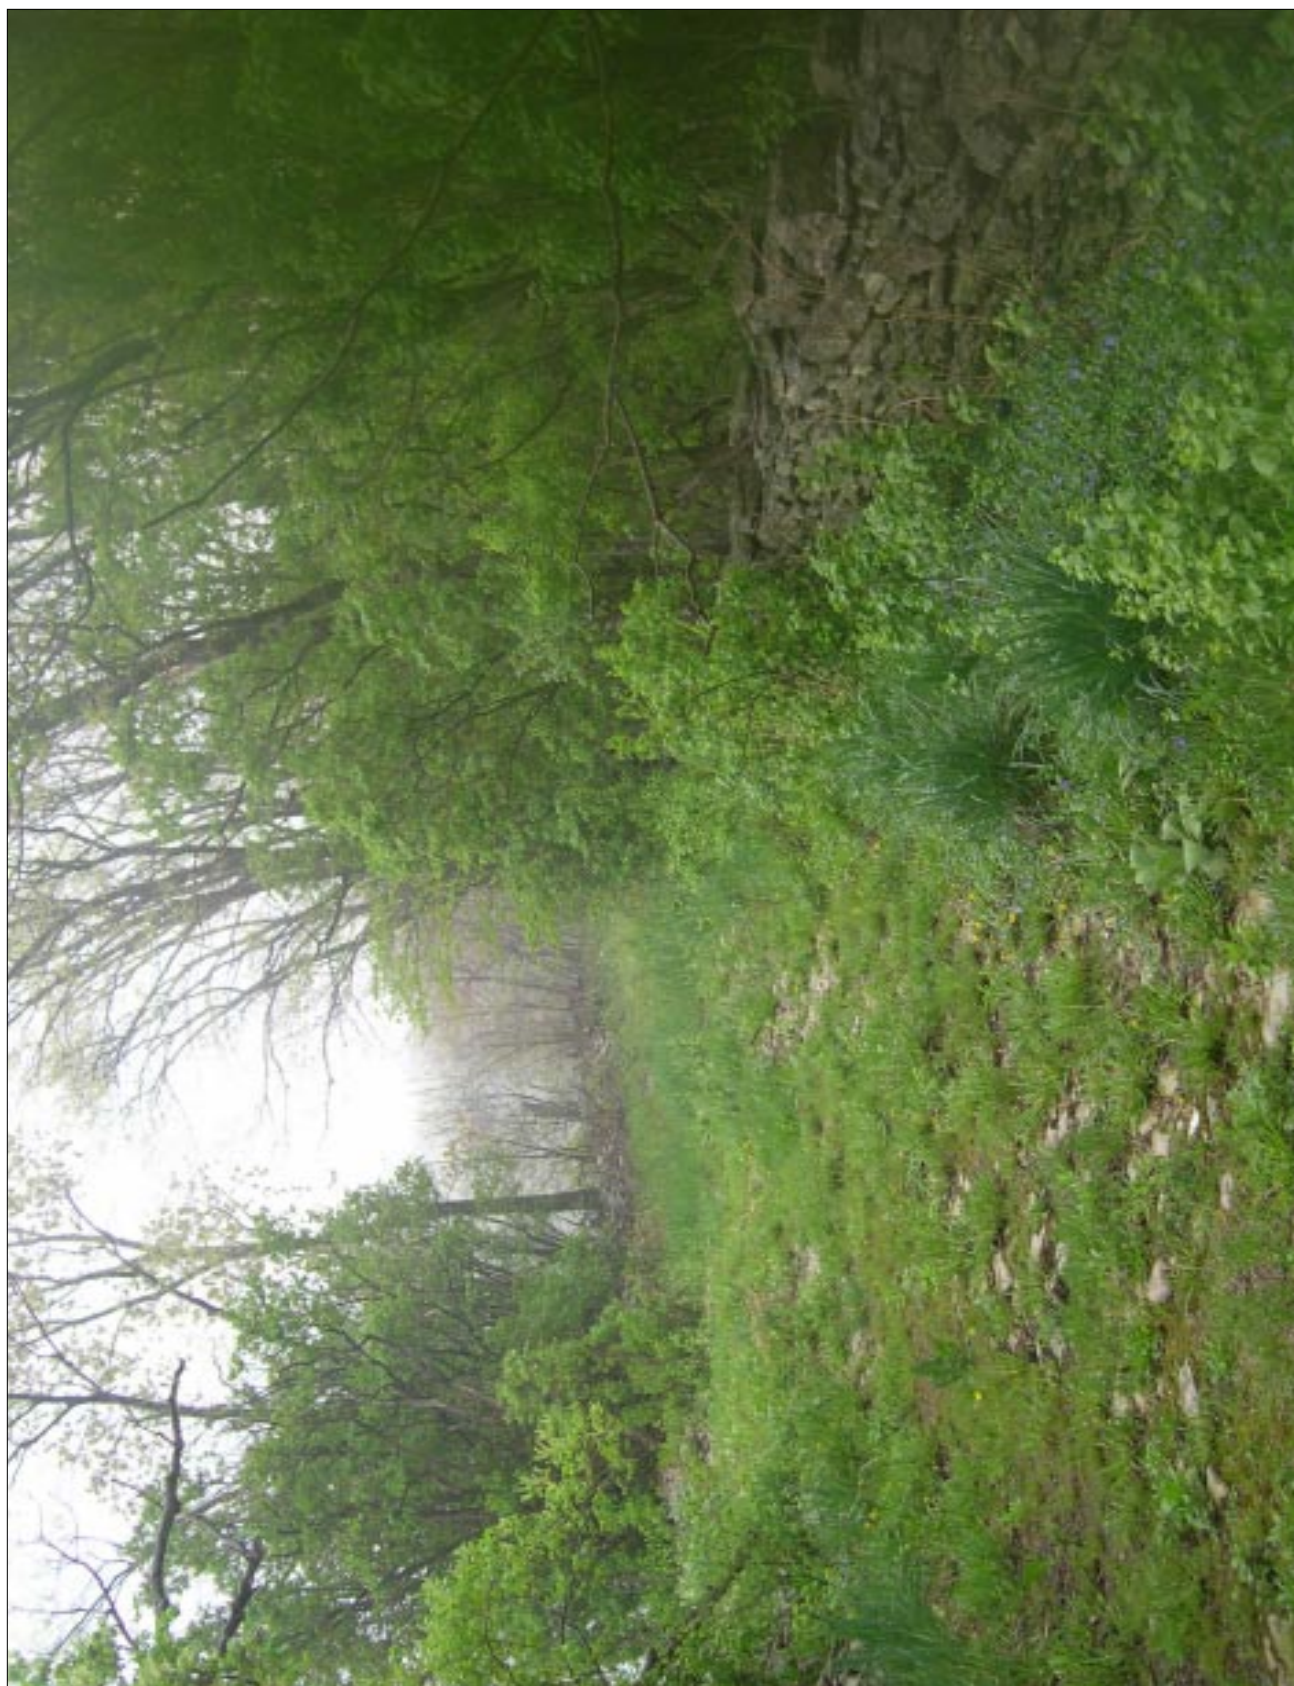
*Image LW-4. Lincoln Stone Wall near its northeastern terminus; note proximity of abandoned Monagan Road and Lake Erie shoreline; storm berm of limestone slabs can be seen at left center (April 30, 2004).*

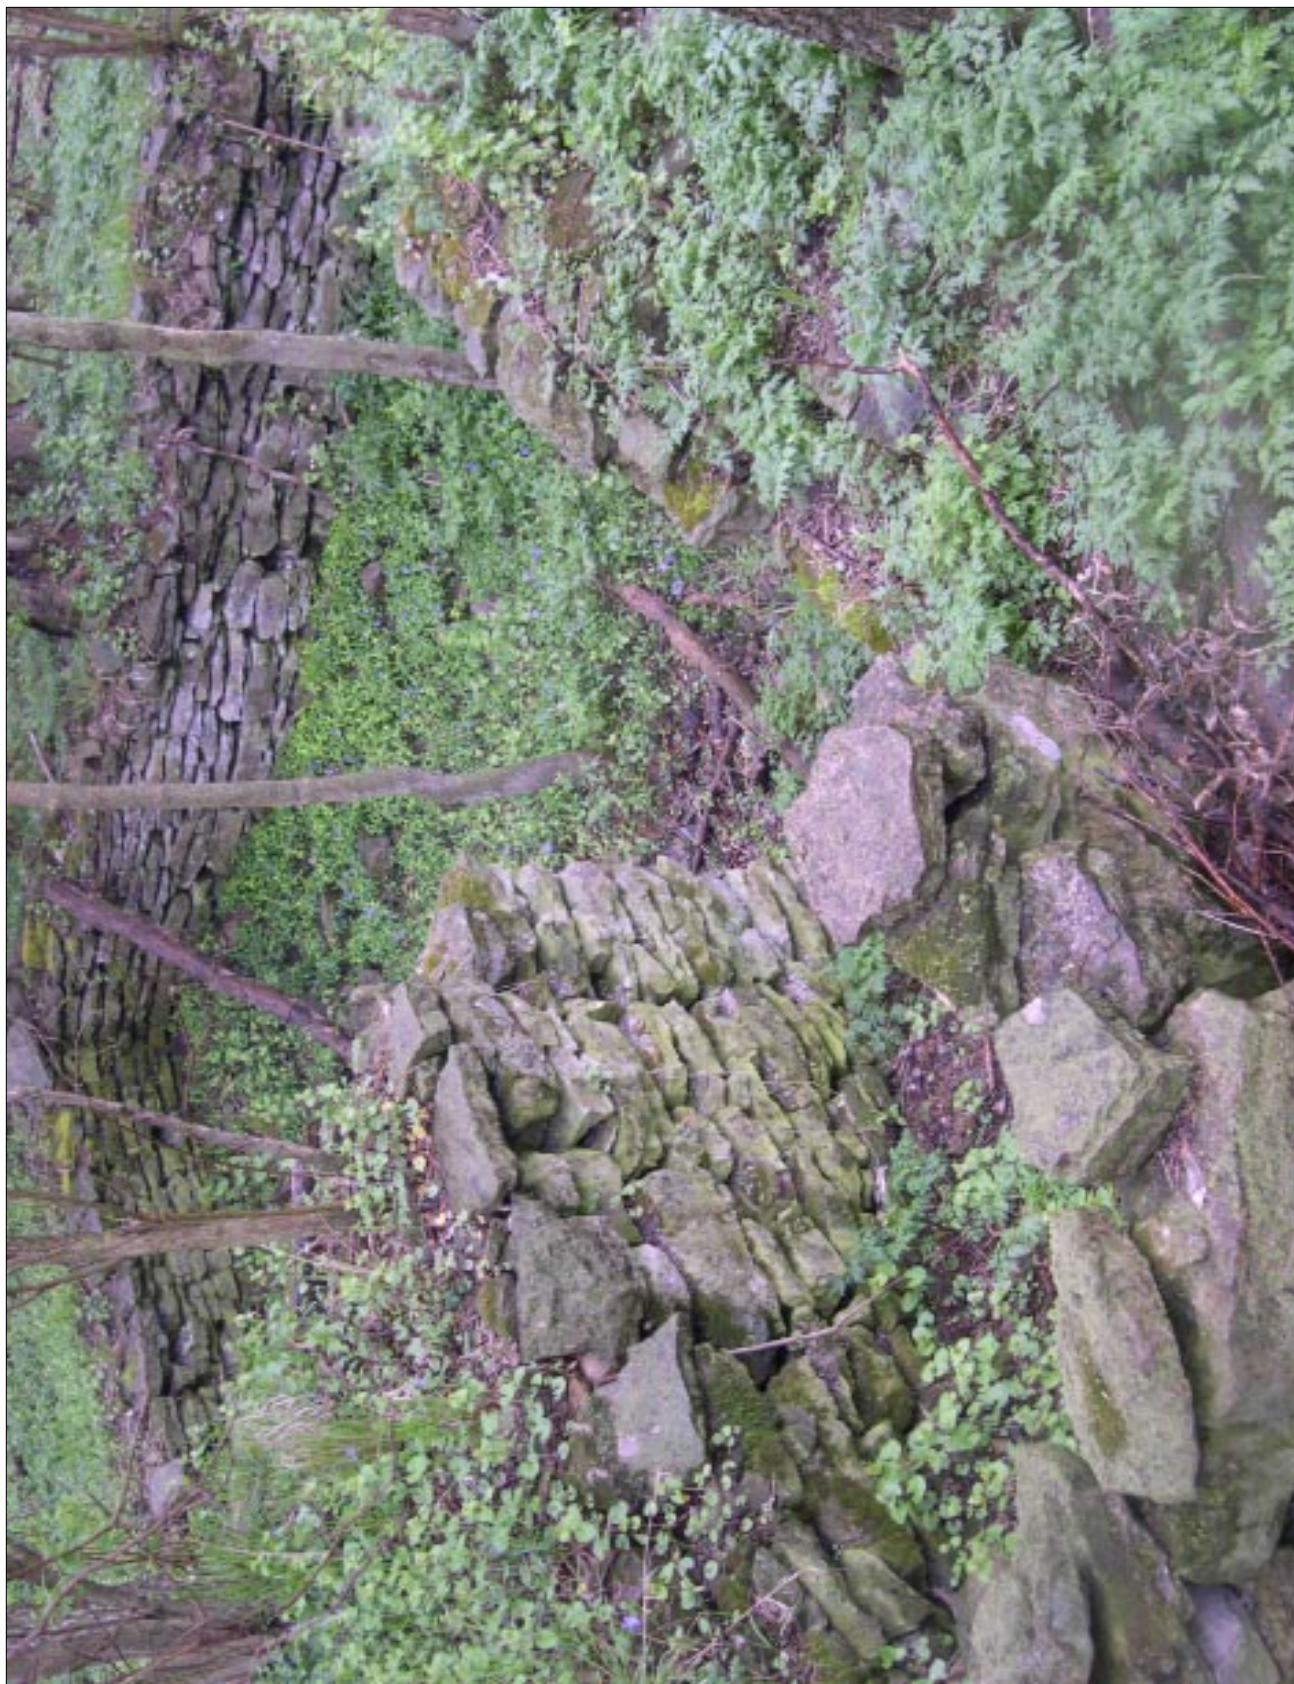
*Image LH-1. Lincoln House foundation (ca. 1865), showing stairway and cellar walls of dry-laid limestone slabs (April 30, 2004).*

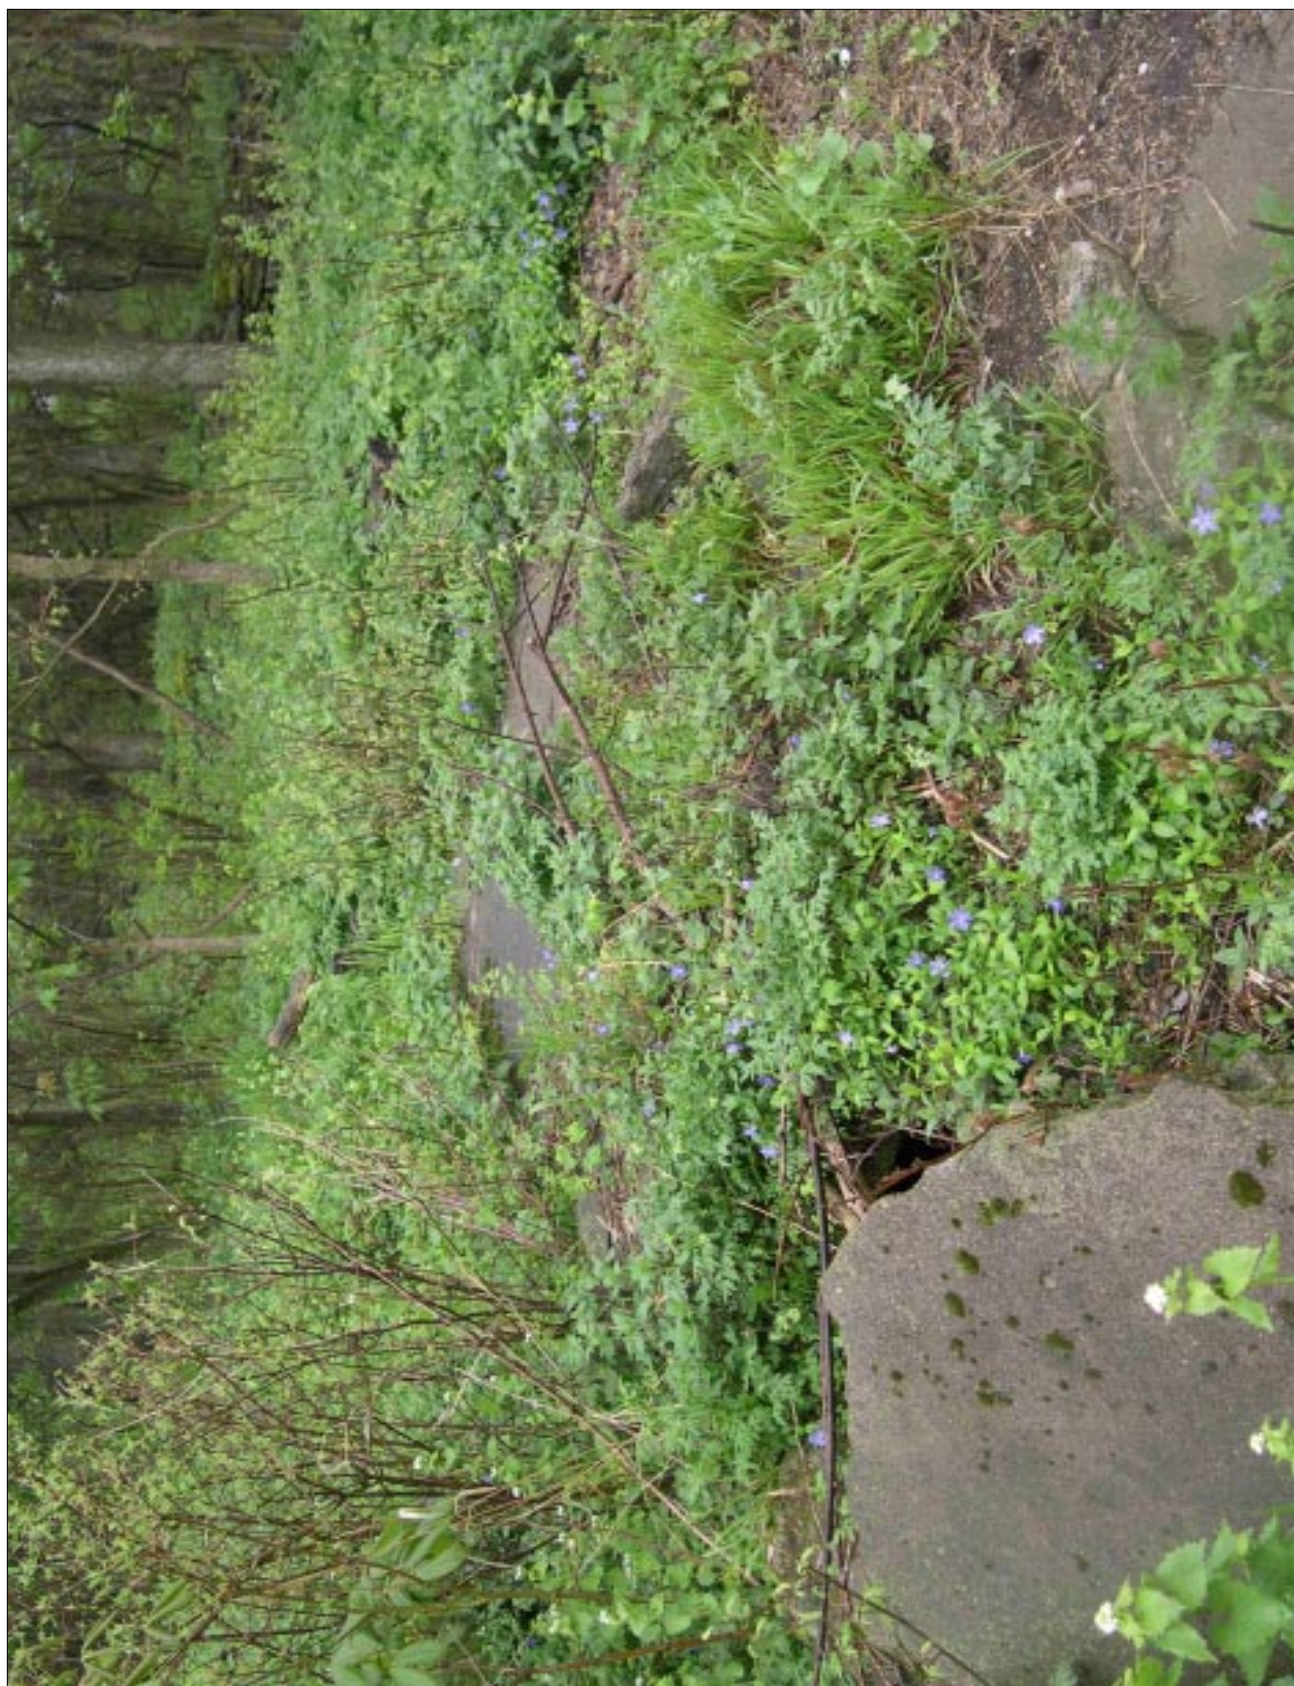
*Image LH-2. Broken cap on concrete cistern (ca. 1900) on western side of Lincoln House; note cellar wall at upper right (April 30, 2004).*

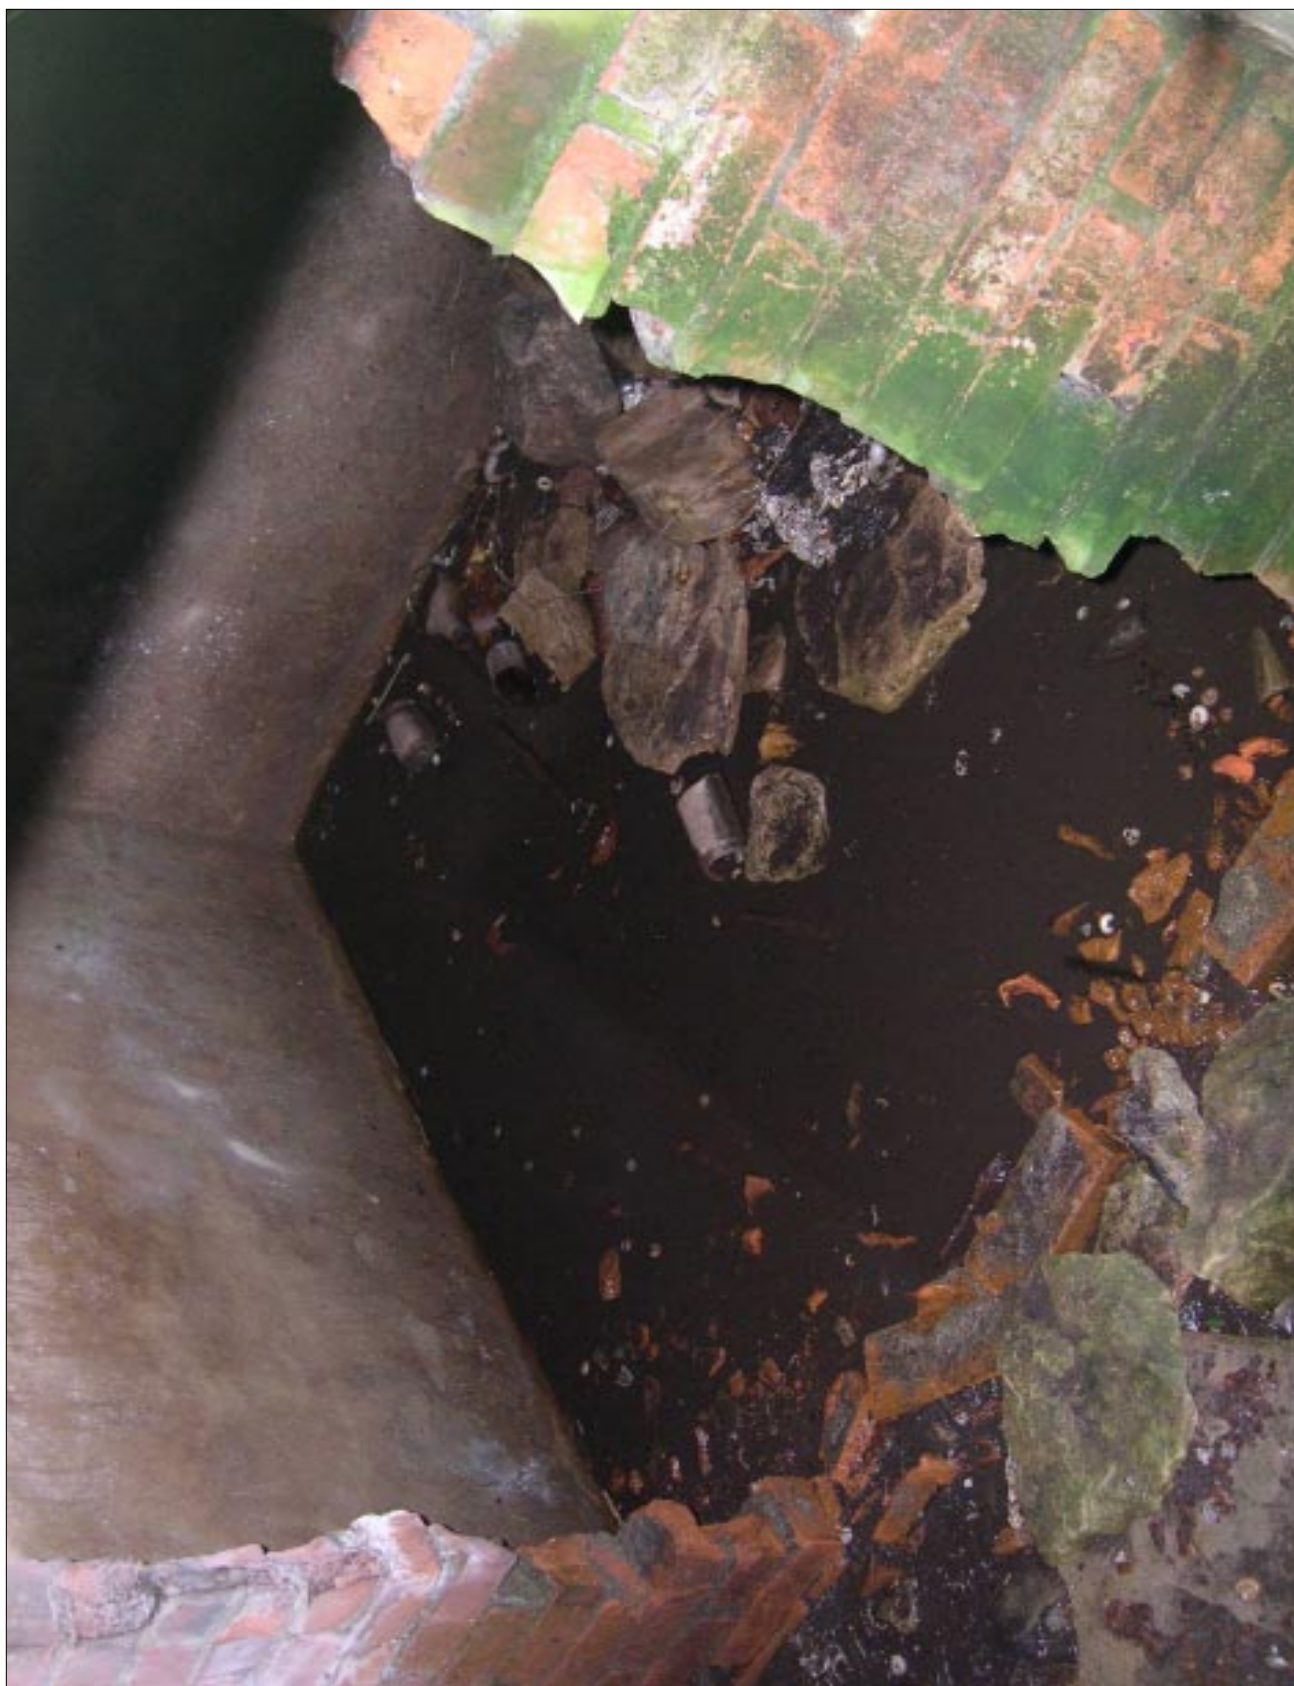
*Image LH-3. View inside concrete cistern at Lincoln House, showing interior brick wall; cistern approximately 1.4 m deep (May 29, 2004).*

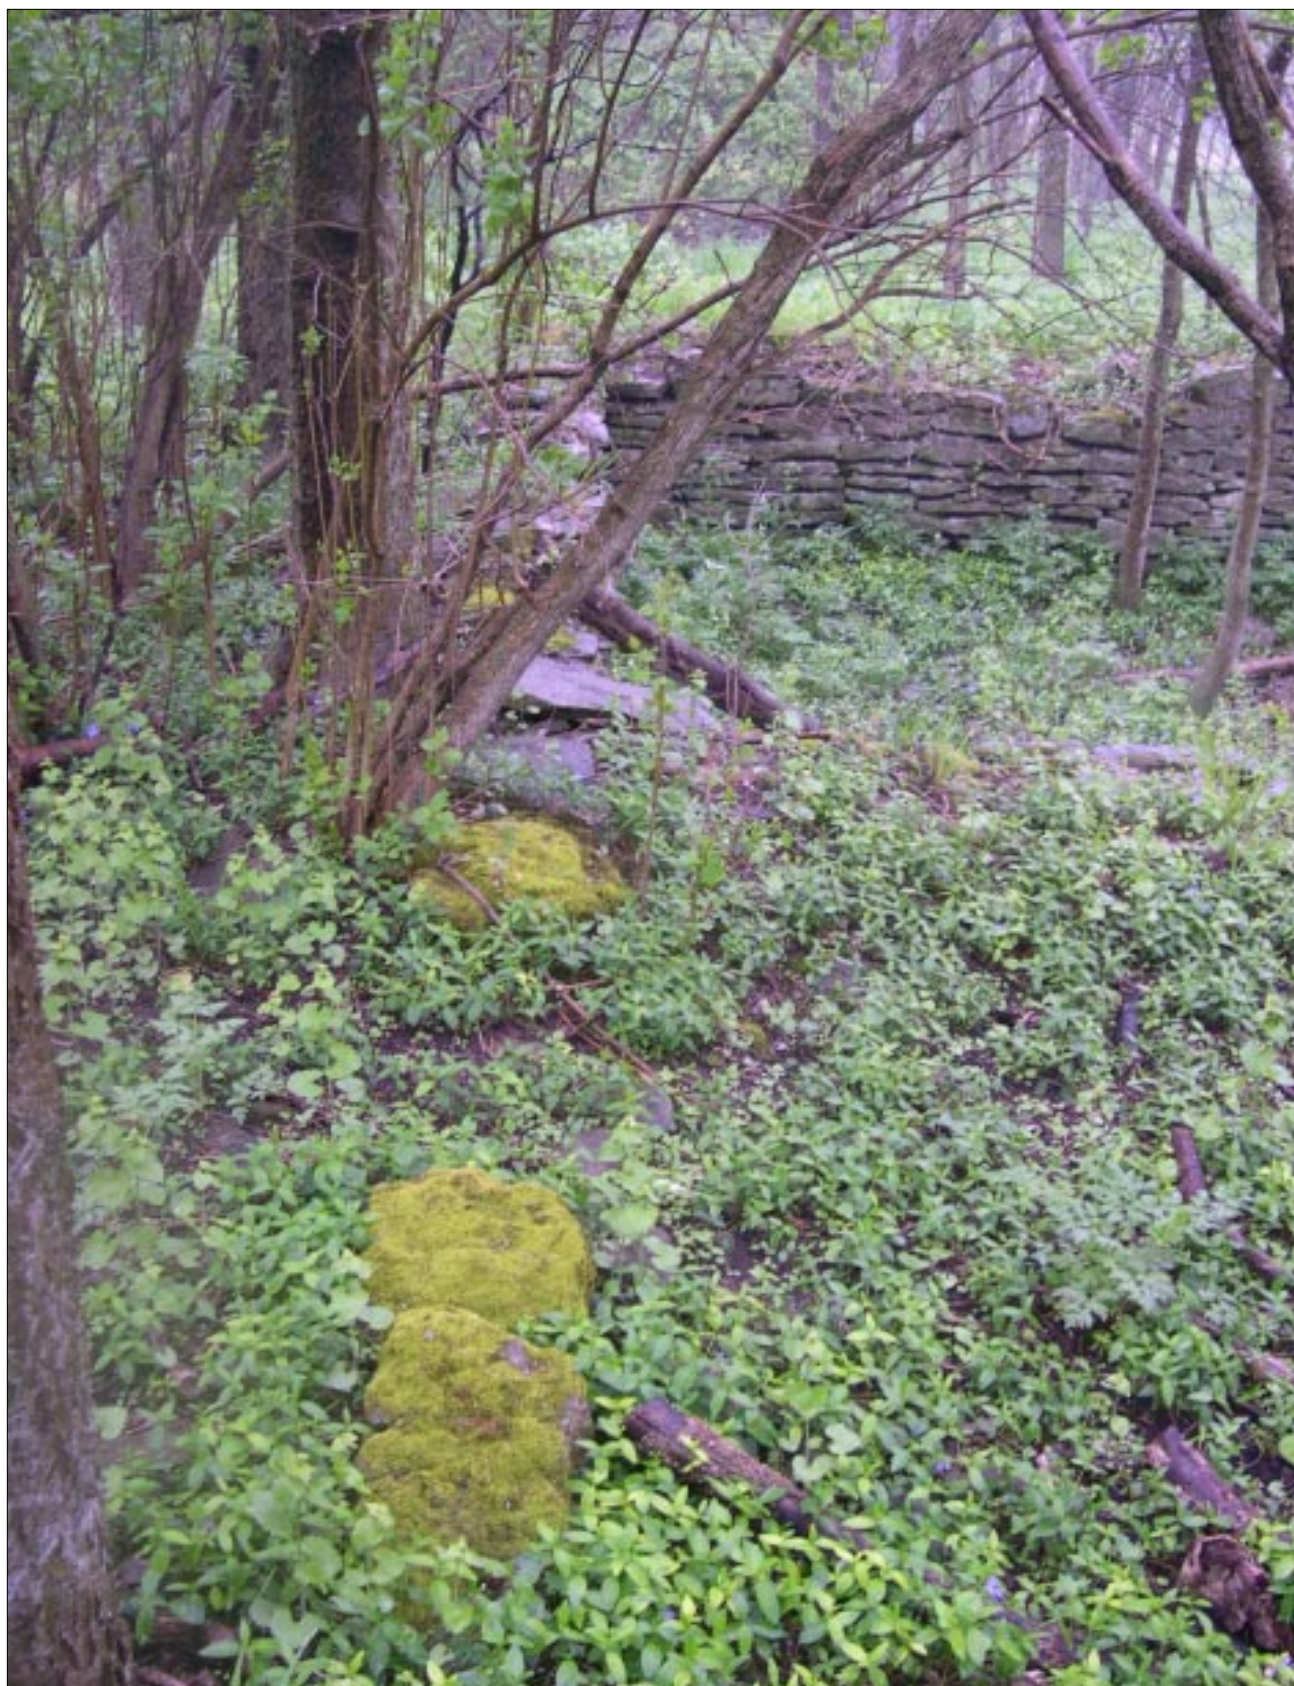
*Image LH-4. Lincoln House foundation stones along east side; note cellar wall at upper right (April 30, 2004).*

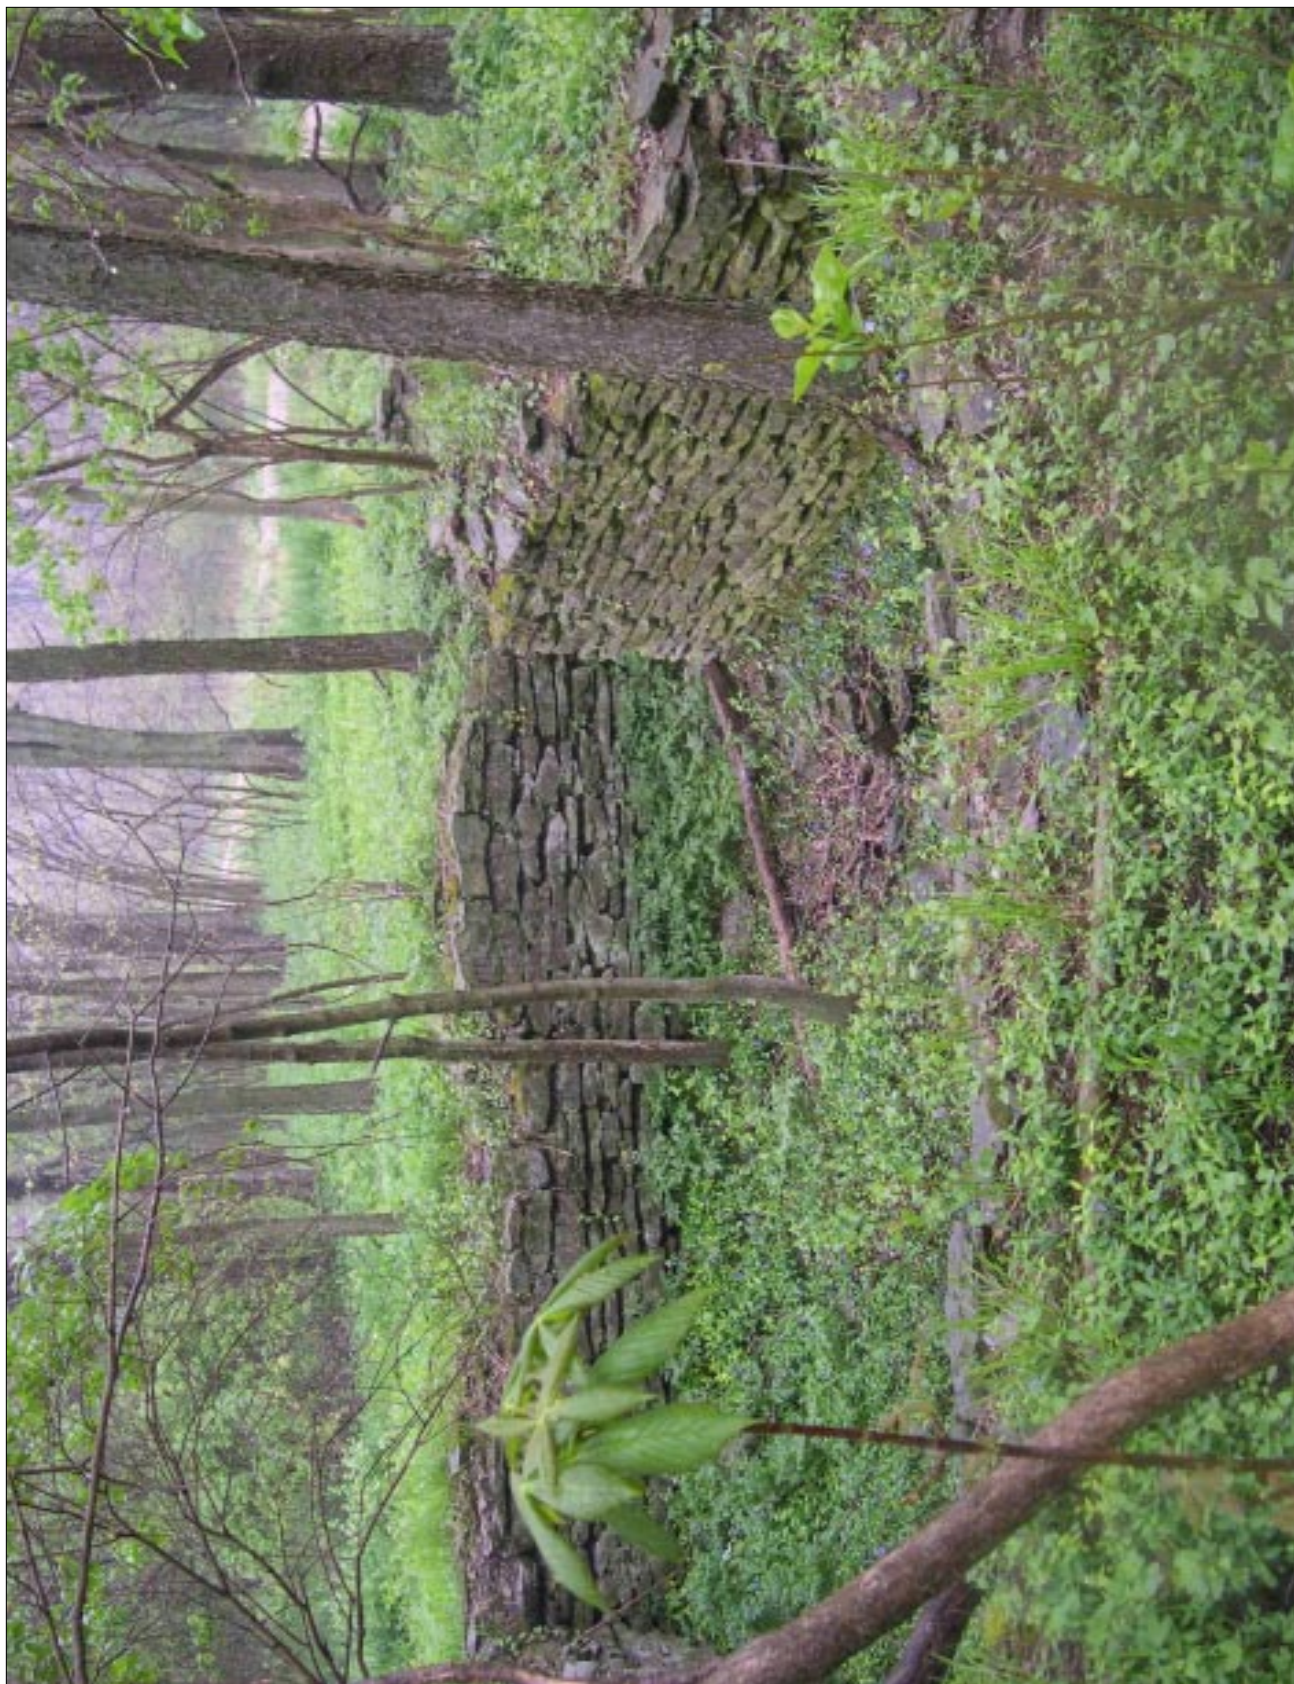
*Image LH-5. Lincoln House cellar walls, showing entrance to stairway at upper right; approximately 1.5 m of wall exposed at stairway (April 30, 2004).*

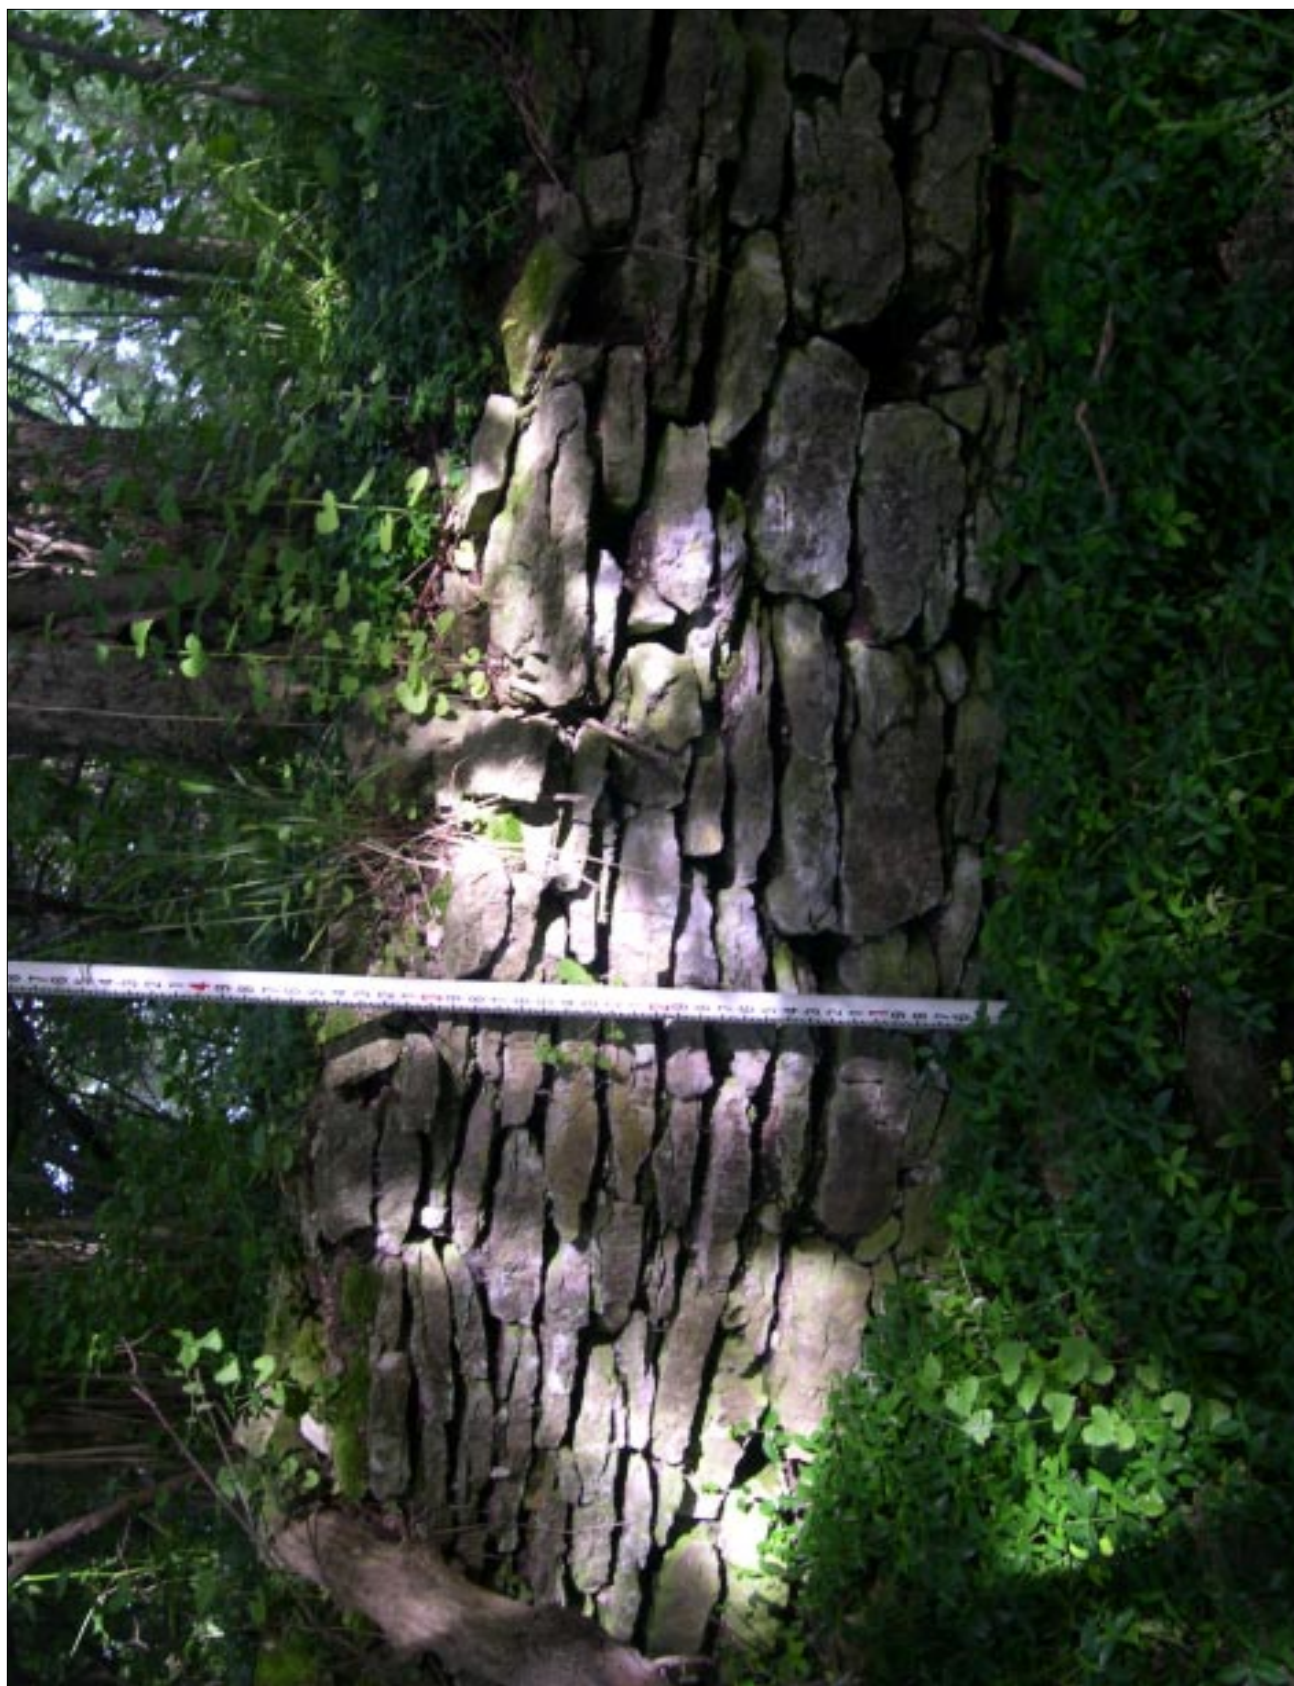
*Image LH-6. East cellar wall of Lincoln House; stadia pole marked in feet and tenths (May 29, 2004).*

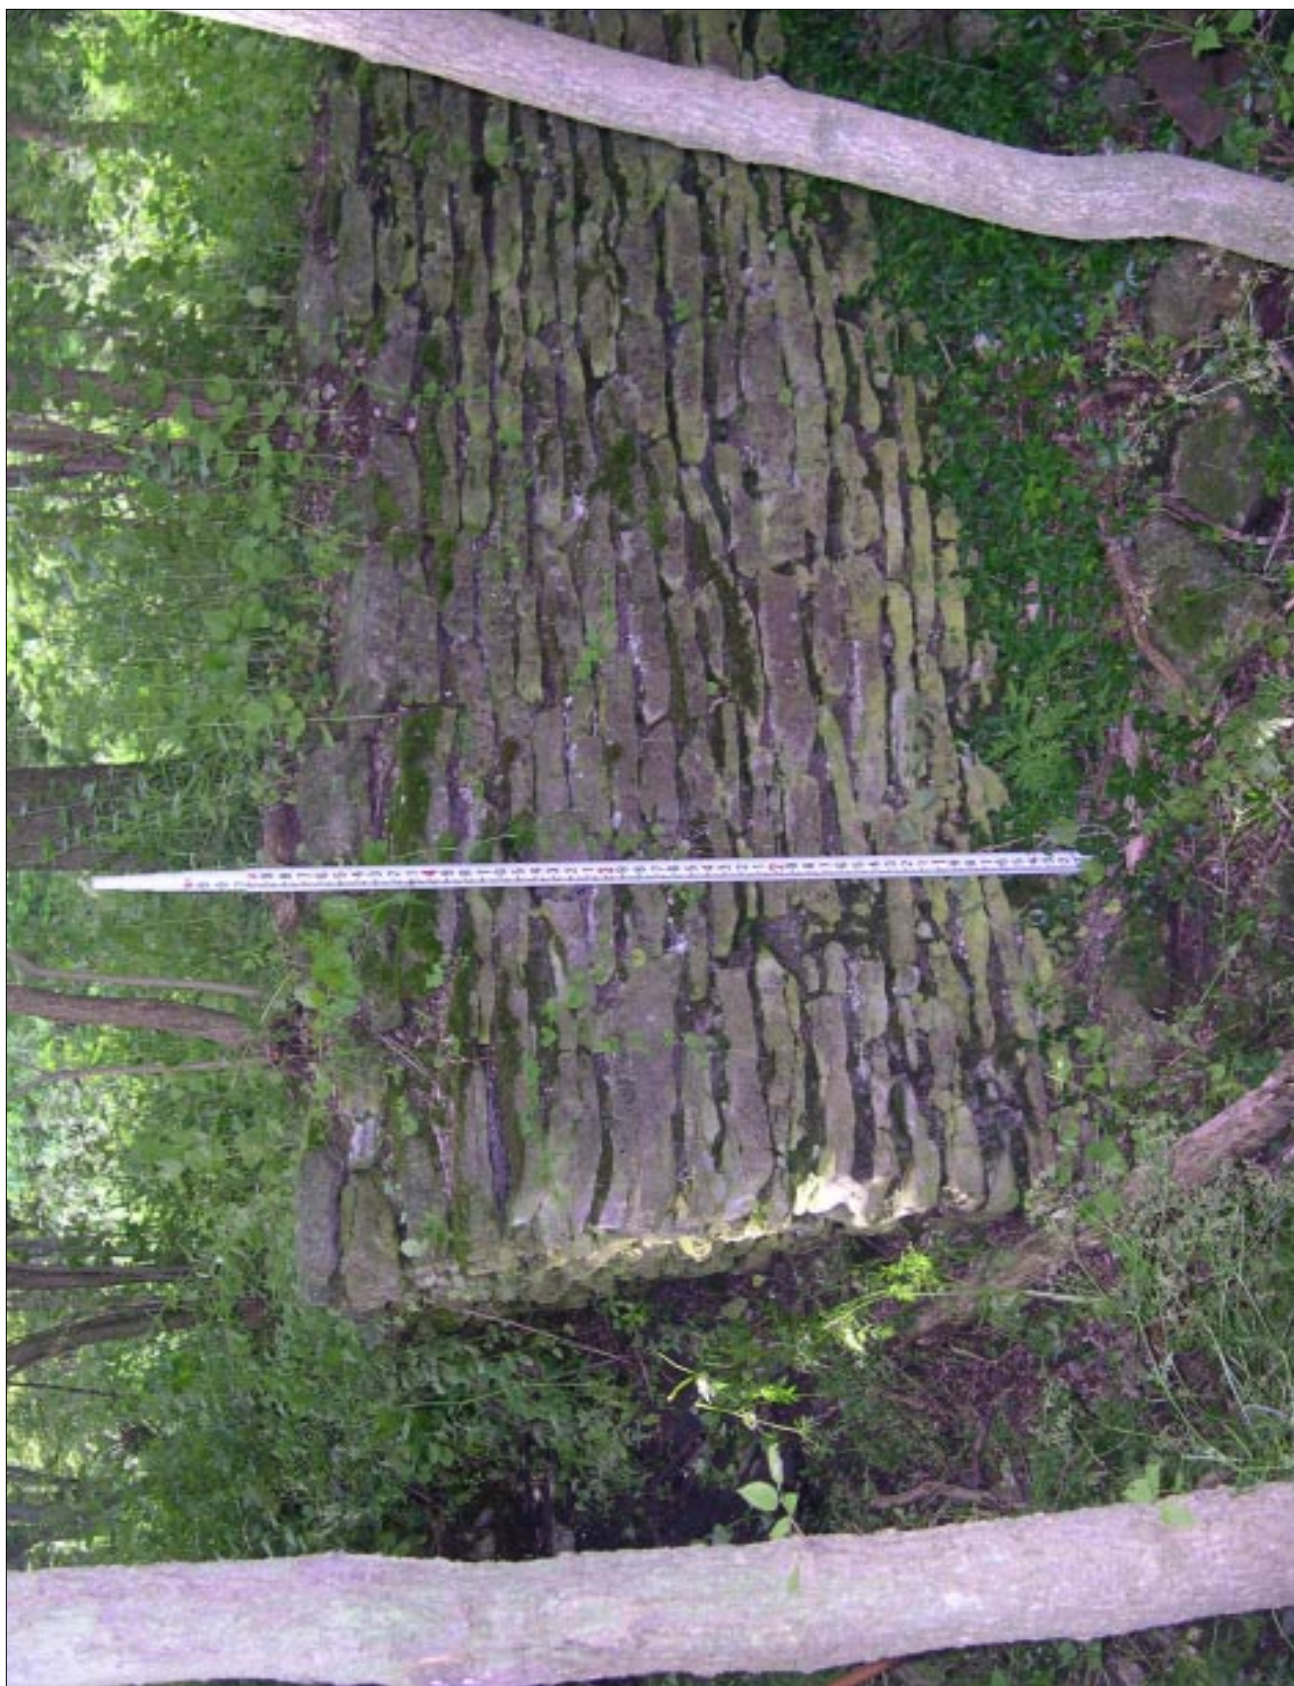
*Image LH-7. West cellar wall and stairway of Lincoln House; stadia pole marked in feet and tenths (May 29, 2004).*
